# Manhole Inspection Summary

Manhole # S43CC\_049MH

Insp Date: **12/19/07 8:51 AM**

**Location** Address: **abbott st**

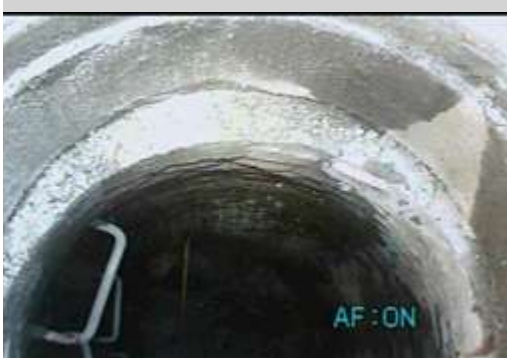
Defect 1

**Steps** Count: **5** Missing: **0** ☒ **Corroded**

STEPS

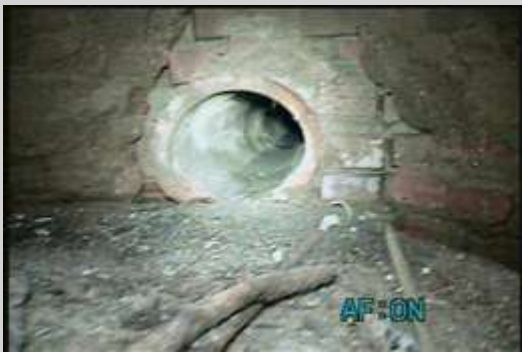
12 O'Clock Outflow

8 in. Circular Gravity Sewer  
Pipe Out @ 12 O'Clock

Silt Depth: **2** (in.) Deposits Extent: **Light**

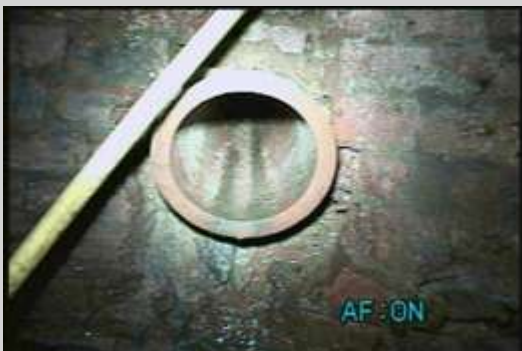
5 O'Clock Inflow

8 in. Circular Gravity Sewer  
Pipe In @ 5 O'Clock

Connects To: **Stub connection / abandoned**

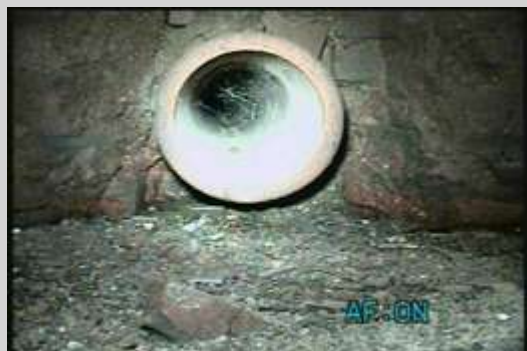
9 O'Clock Inflow

8 in. Circular Gravity Sewer  
Pipe In @ 9 O'Clock

Connects To: **Stub connection / abandoned**
